PHOTOS

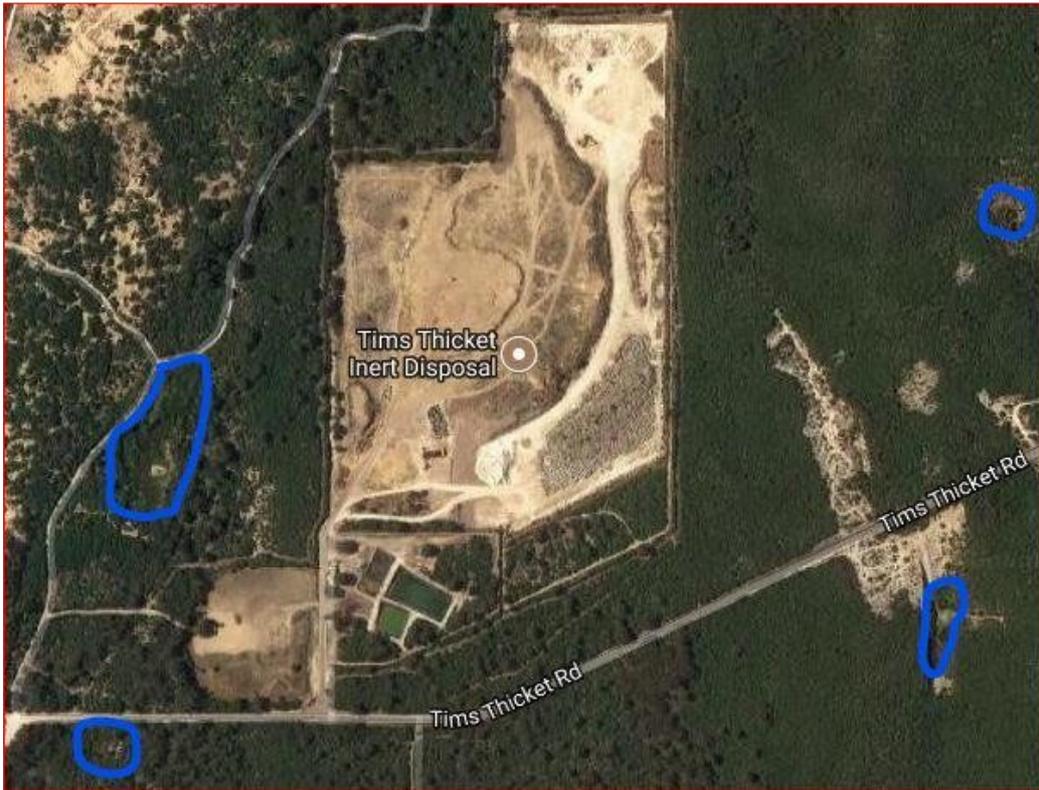
Photo 1. Wetlands and Damplands locations within 500m but not identified in COM septage proposal.

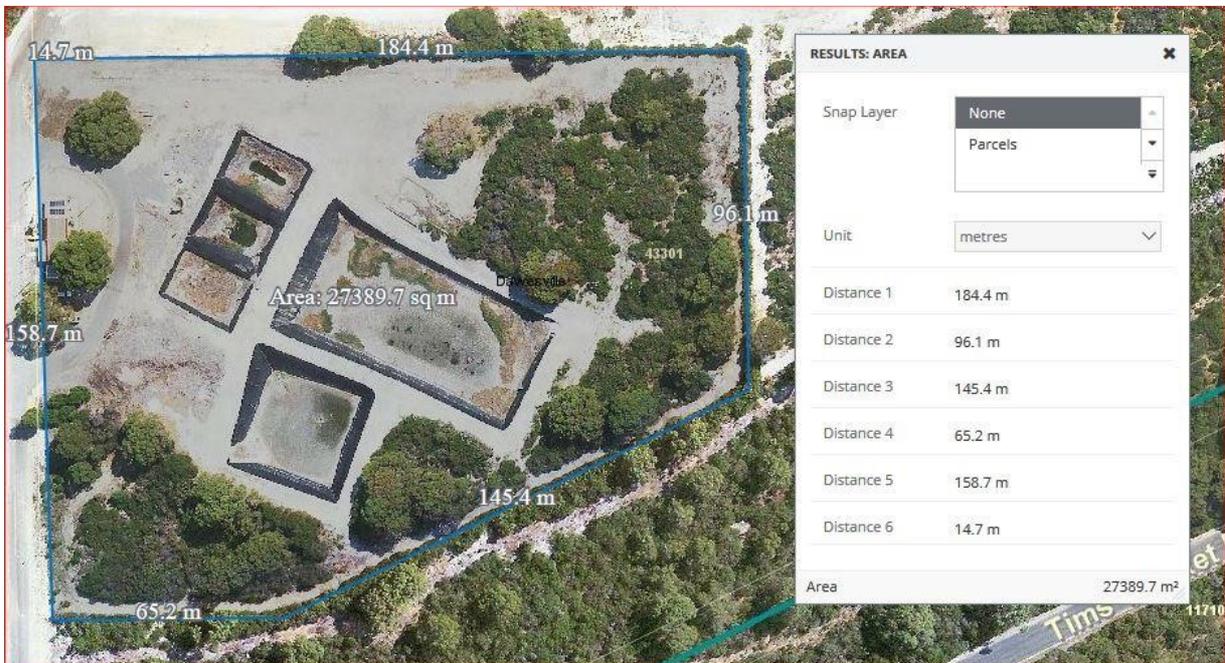
Photo 2. Existing septage plant area = 2.7ha (1ha = 10,000m²)

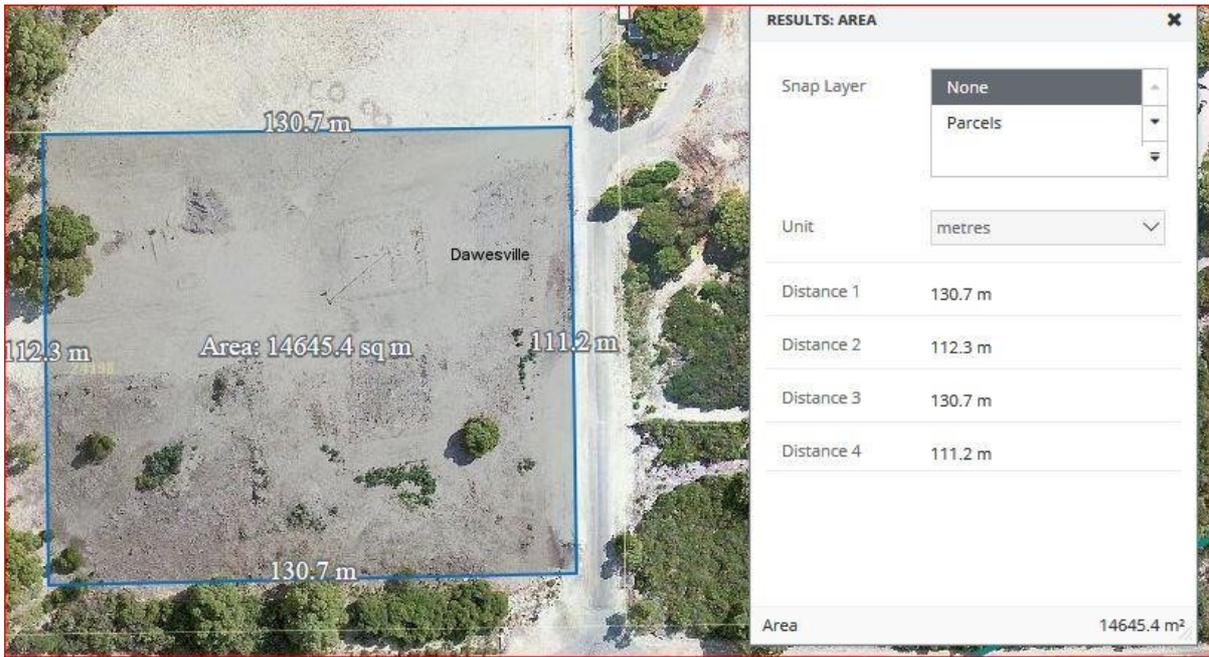
Photo 3. Area of requested sprayfield = 1.4ha (1ha = 10,000m²)

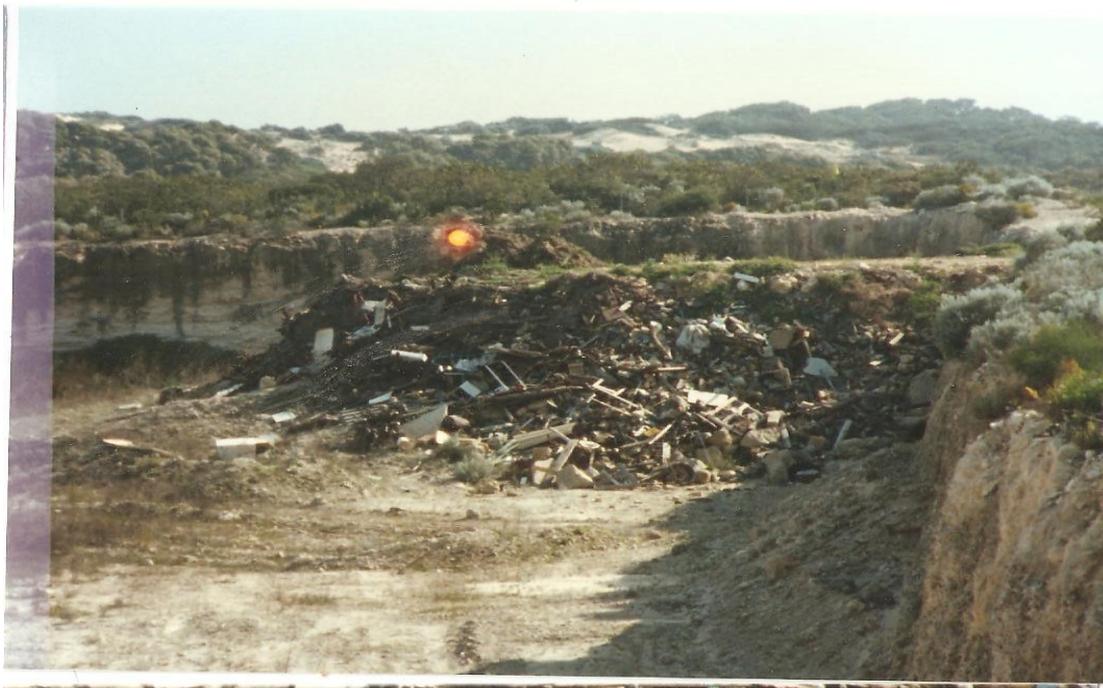
Photo 4. Hard waste deposited in reserve 24198 – 1997. Looking north along east side of pit at petrucibles, wood, cardboard. This particular material is actually in WAWA reserve 39349 on the north border of the limestone pit in reserve 24198.

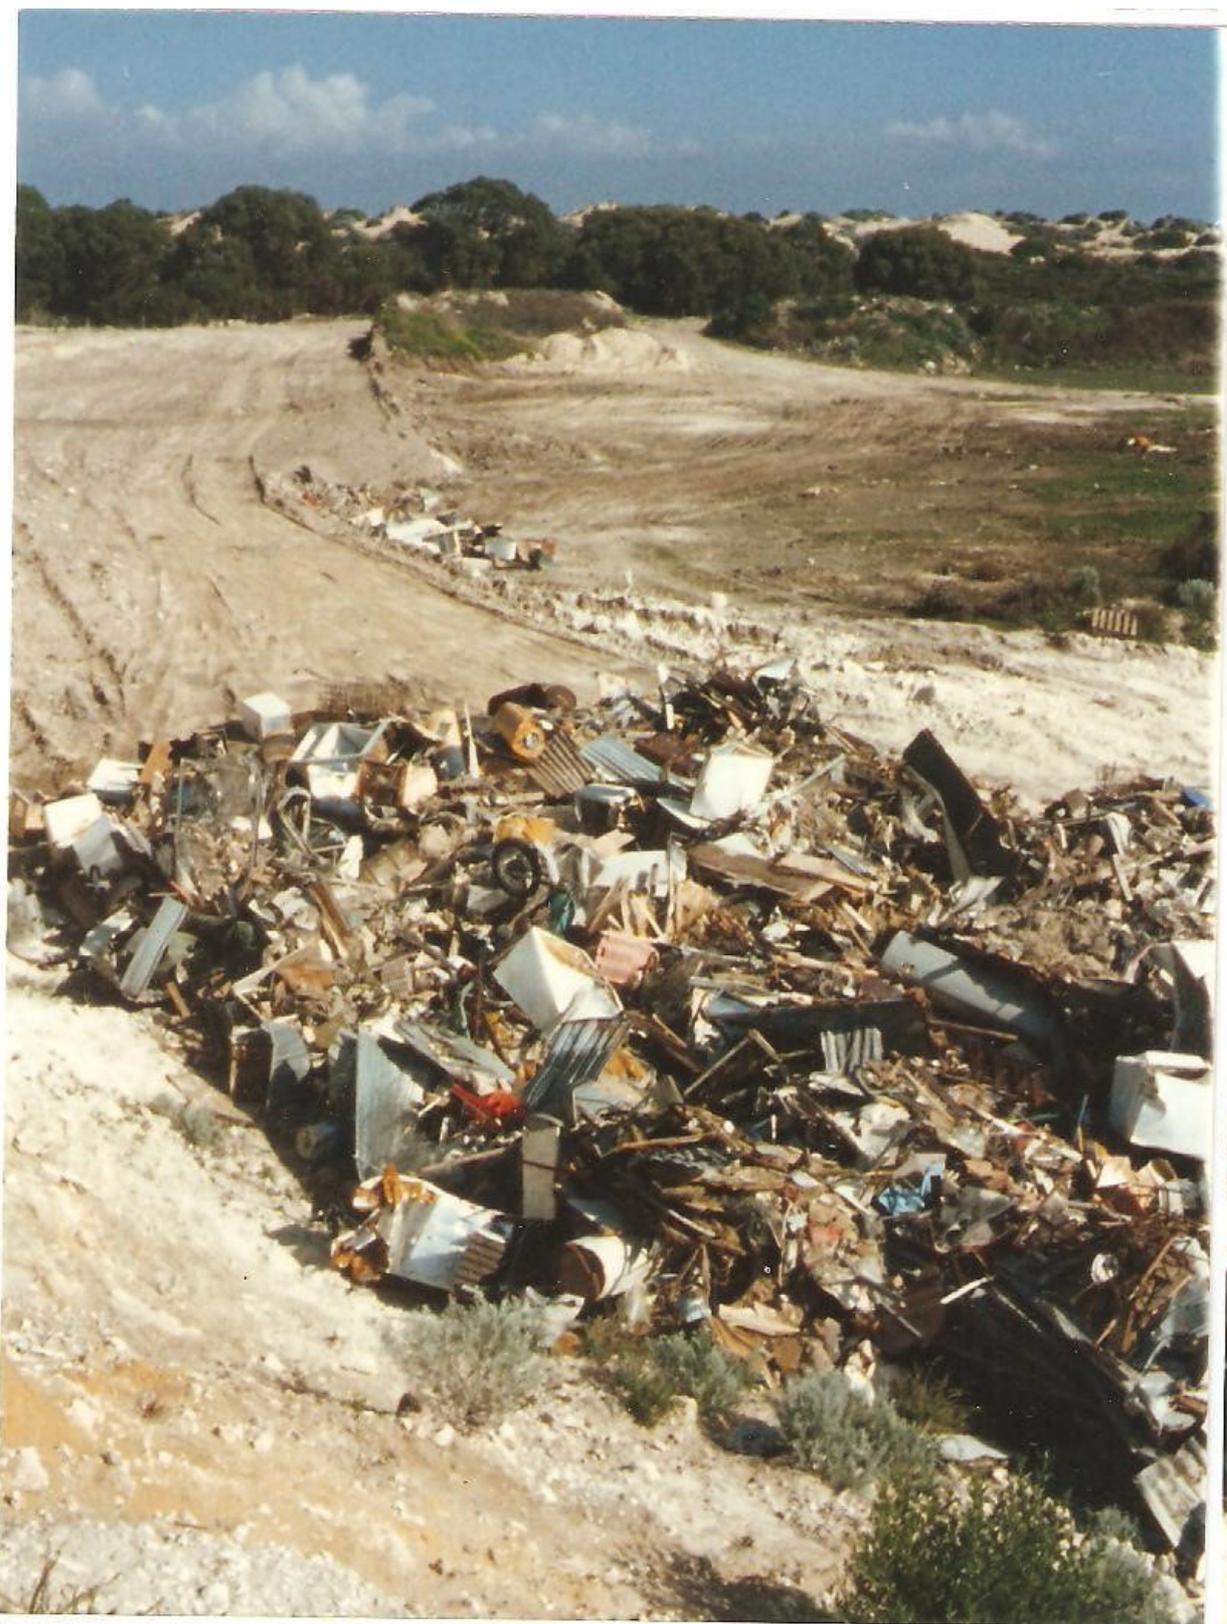
Photo 5. Hard waste deposited in reserve 24198 – 1997. Looking west at entrance track. 9kg gas bottles, white goods, tyres, metals, water heaters, refrigerators, wood, plastics, chemical drums, roof iron, car parts, electrical goods, car batteries, furniture. **This is the site of the proposed sprayfield in reserve 24198.**

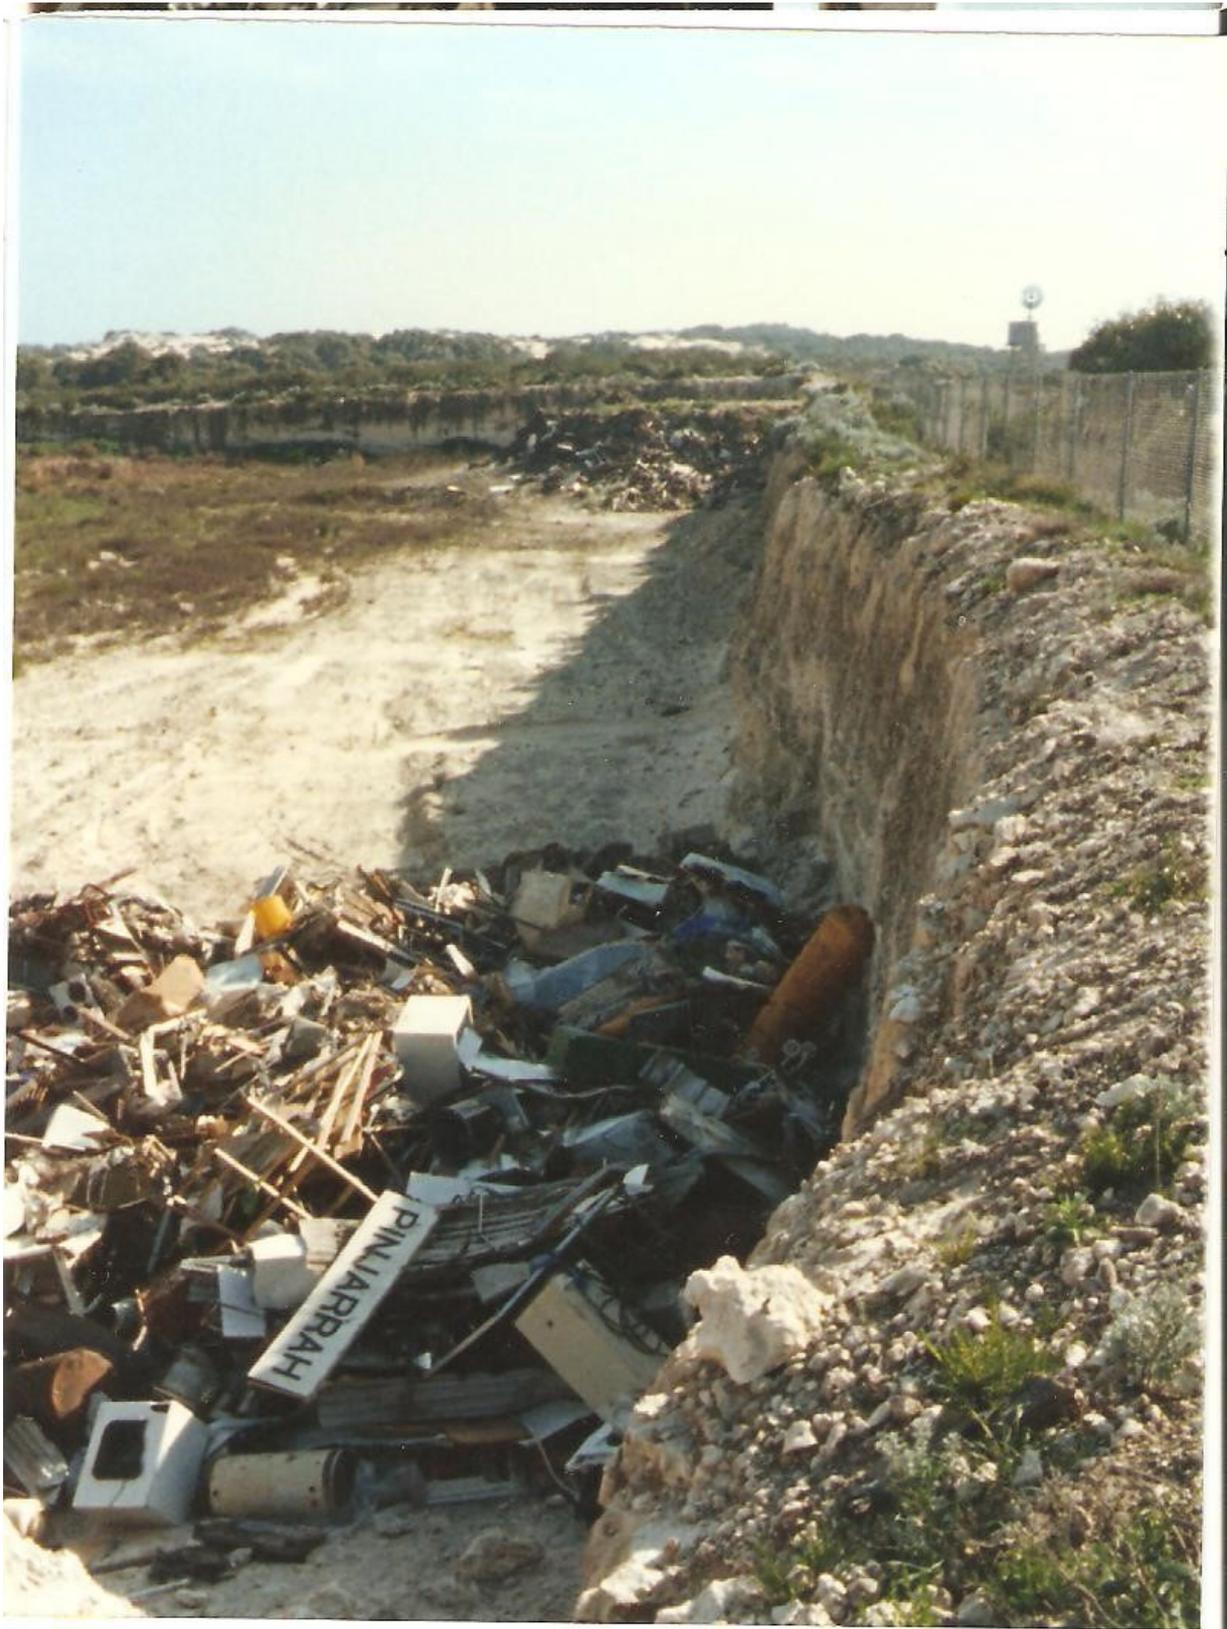
Photo 6. Hard waste deposited in reserve 24198 – 1997. Looking north along east side of pit. The gap to petrucibles in the top of frame was all filled in with same hard waste then eventually covered with crushed limestone. **This is the site of the proposed sprayfield in reserve 24198.**

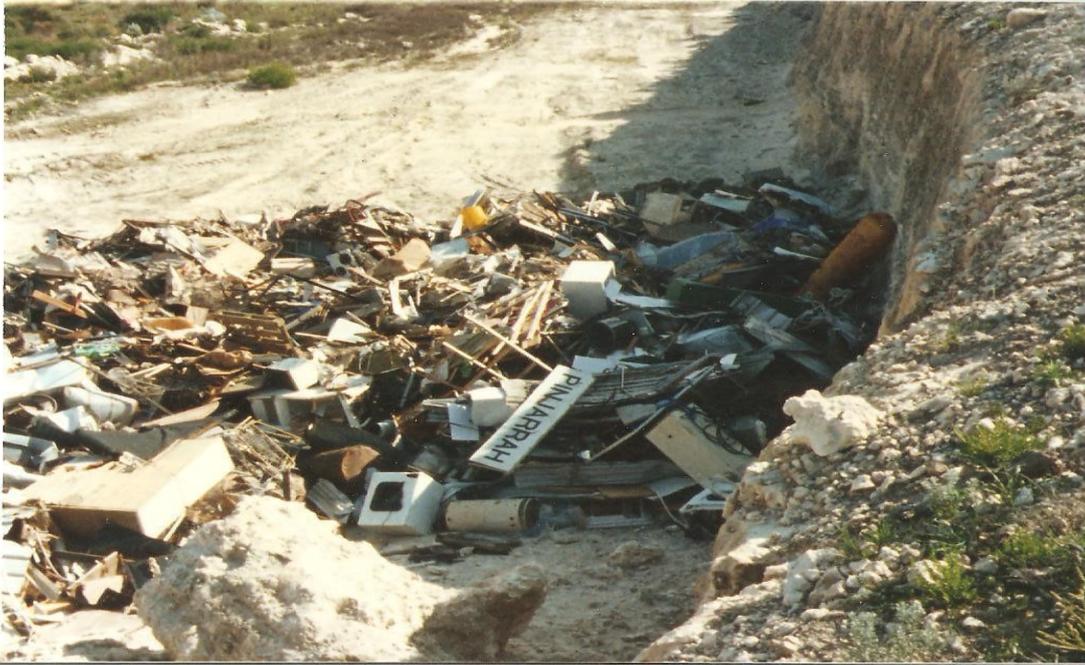
Photo 7. Hard waste deposited in reserve 24198 – 1997. Looking north along east side of pit. Waste consists of 9kg gas bottles, white goods, tyres, metals, water heaters, refrigerators, stoves, wood, plastics, chemical drums, roof iron, car parts, electrical goods, car batteries, furniture. **This is the site of the proposed sprayfield in reserve 24198.**

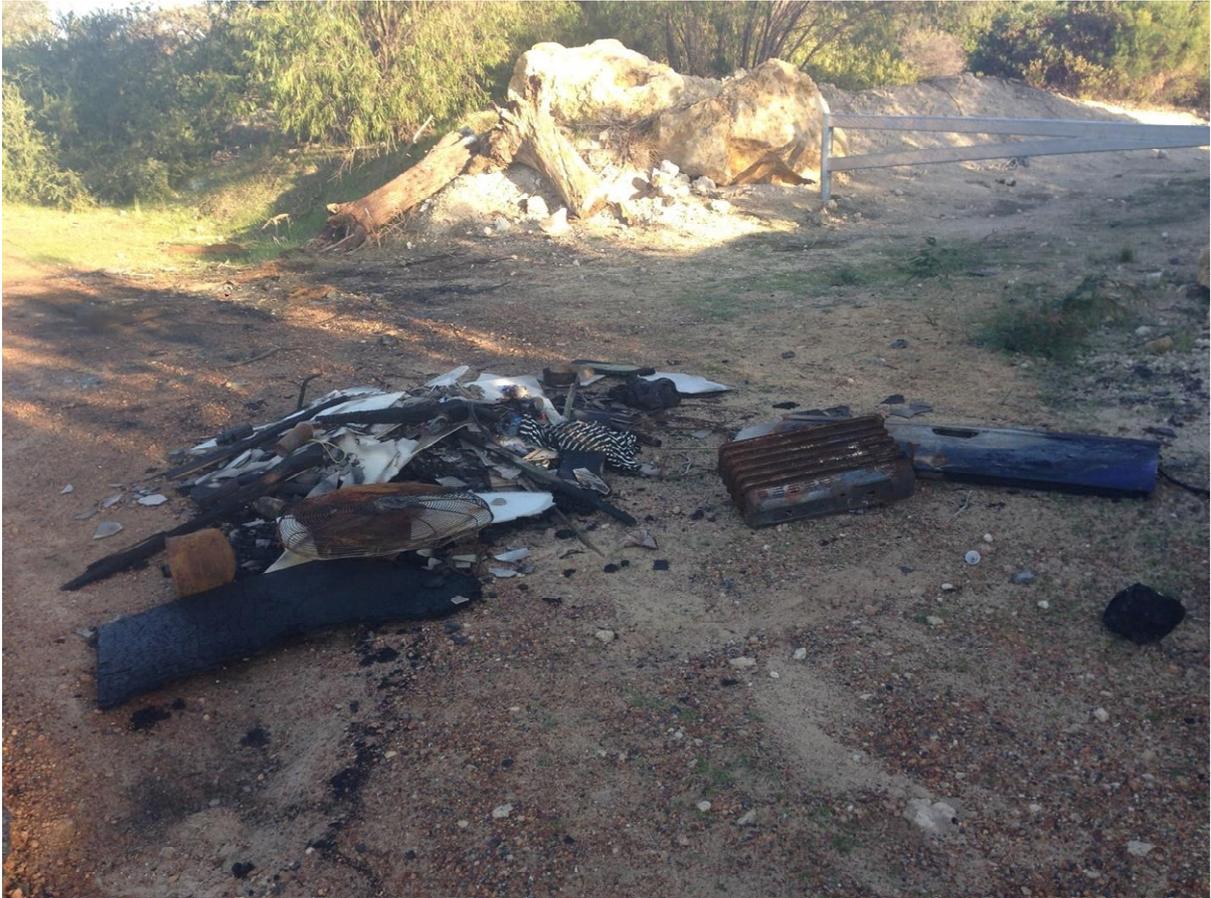
Photo 9. This waste was dumped on Tims Thicket road near to the gate to reserve 43301 and reported in early Jun 2016 to COM. It was collected by a frontend loader (from the inert fill site) as visible scrape marks were left by the bucket. Note it contains broken asbestos sheet.

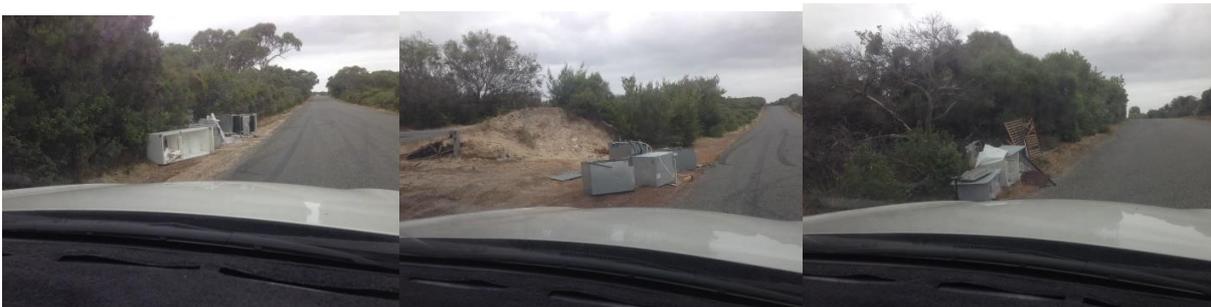
Photos 10: Shows some of just one night's illegal dumping on Tims Thicket Road, 18 Mar 2017.

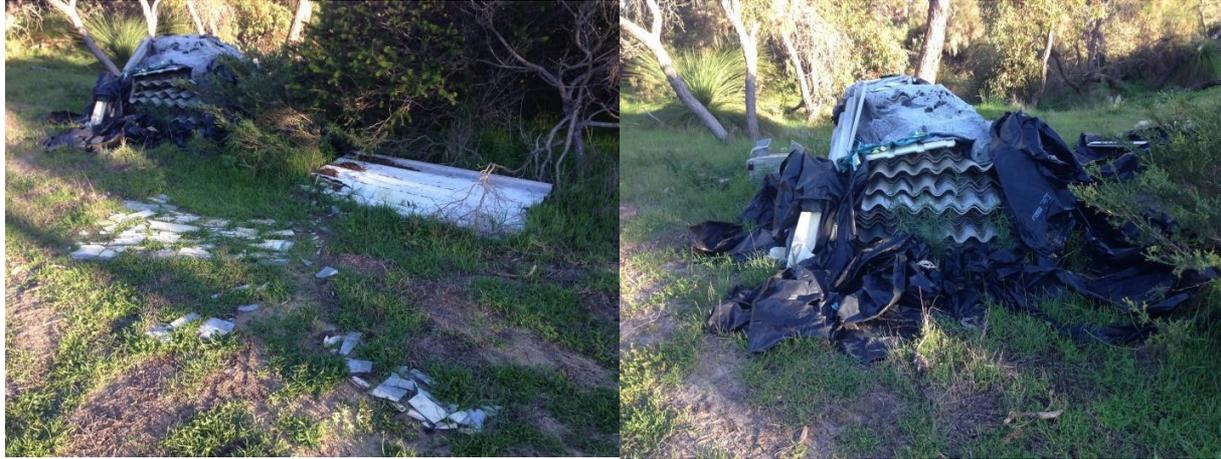
Photo 11. Asbestos dumped on reserve 2851 Old Coast Road sometime prior to 3 Jun 2016. This was plastic wrapped but the plastic had degraded due to sunlight. Removed by COM council shortly after notification.

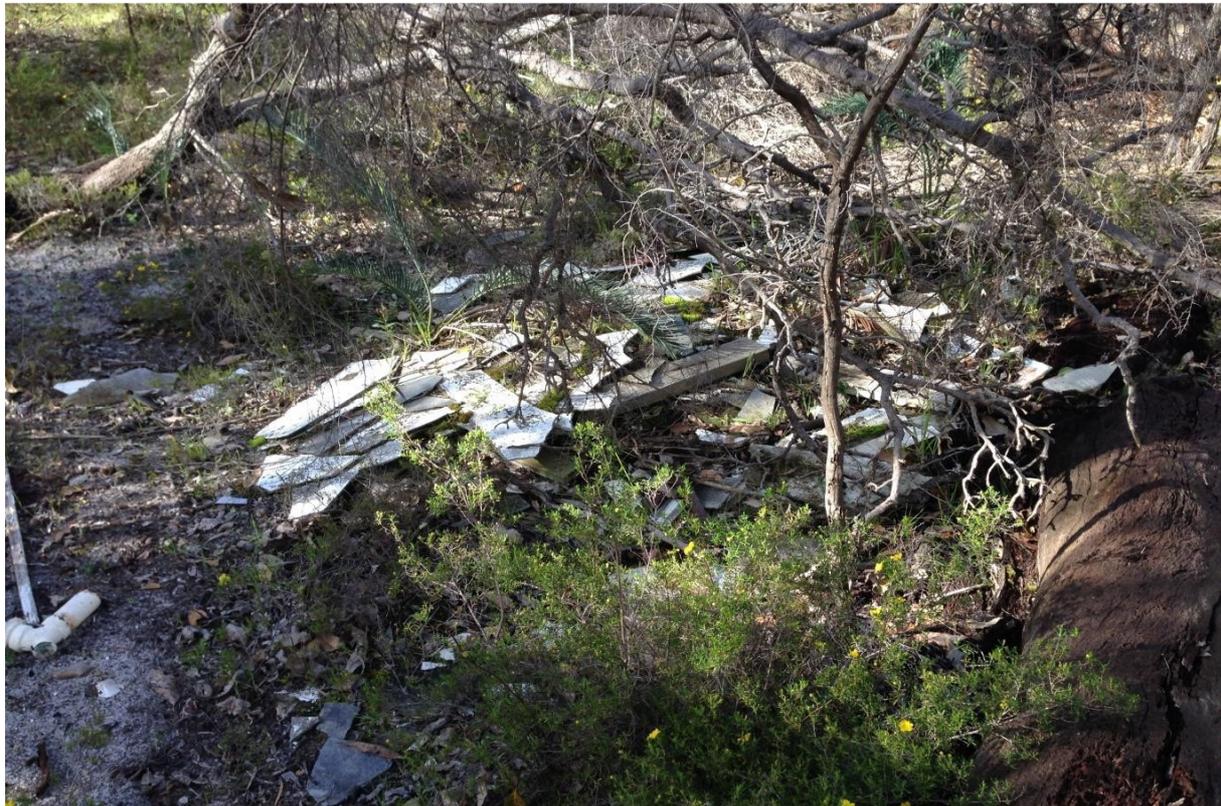
Photo 12. Asbestos dumped on reserve 2990 Herron Point sometime prior to 6 Aug 2016. Originally reported to COM council in Aug 2016, it remains in place to this day, 4 Sep 2017.

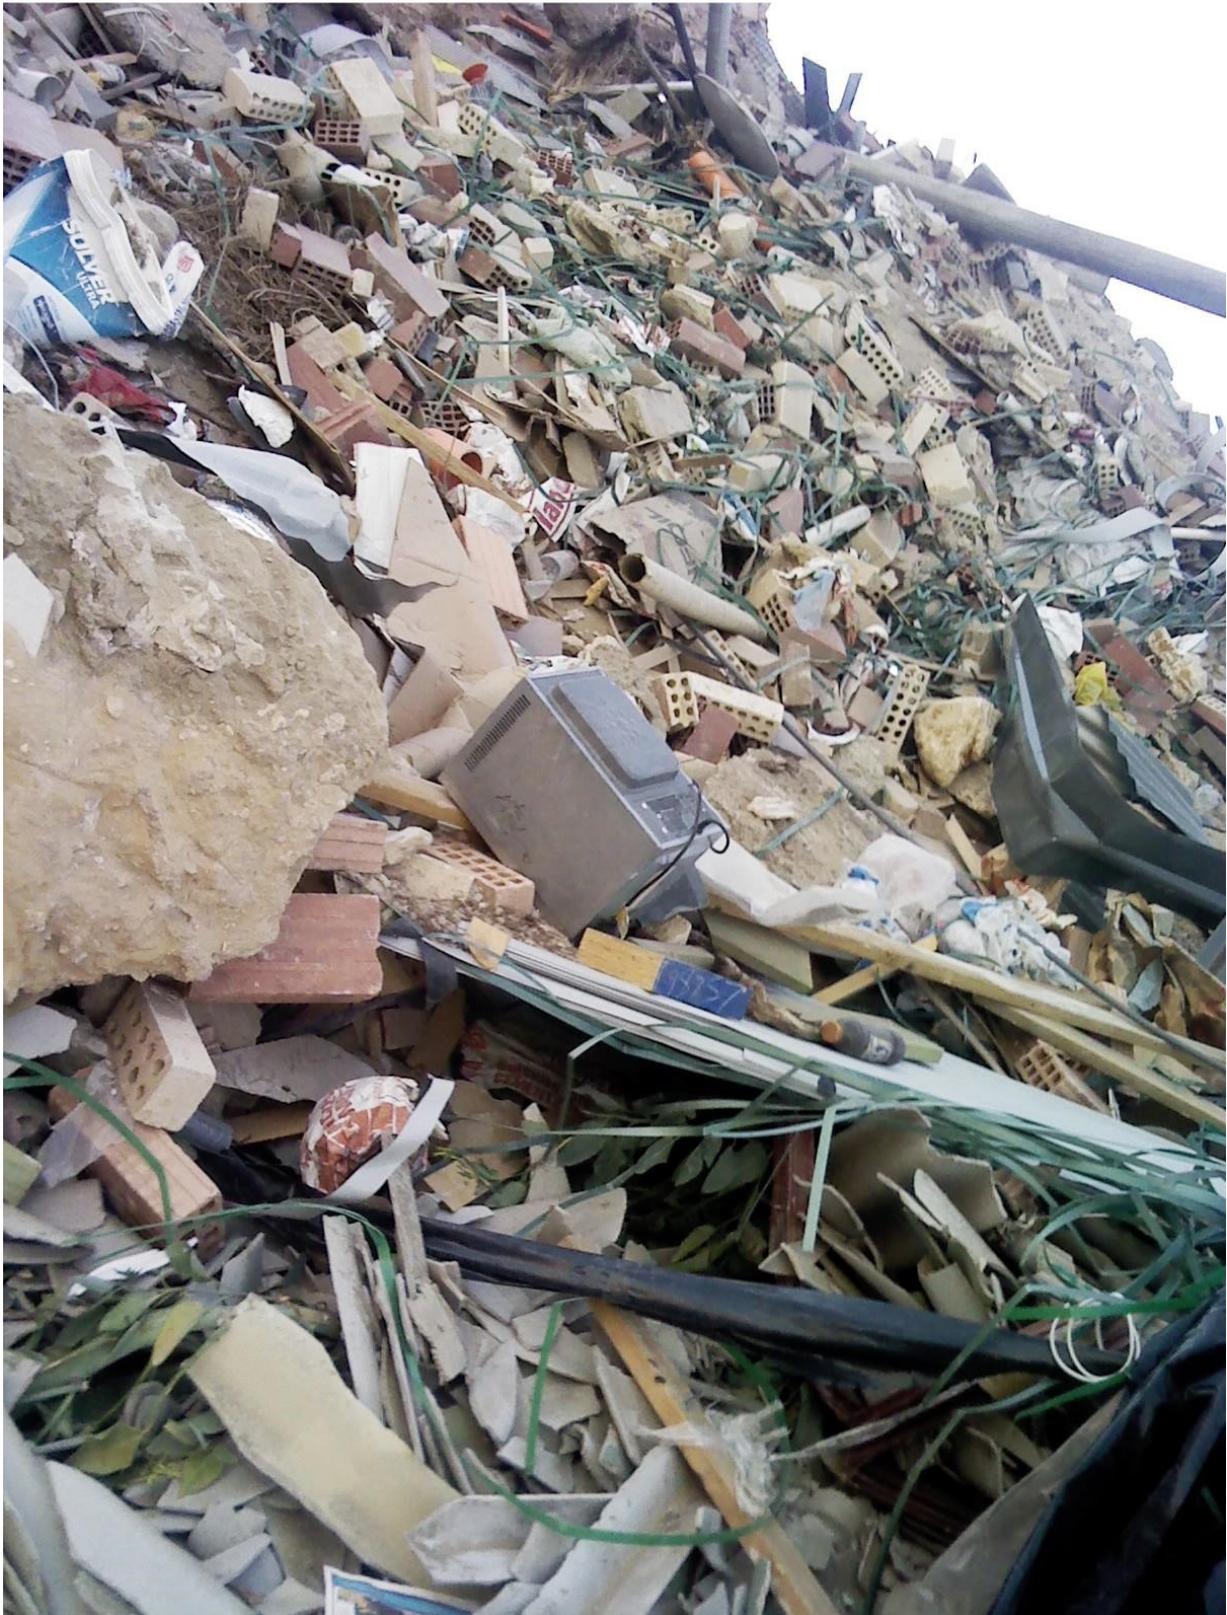
Photo 14. Tip face Mar 2014. A mix of inert and white goods, plastics, cardboard and metals. Of the material in the foreground, the flat white sheet material with the blue wood block on top was fibre cement, below that are corrugated pieces (fibre cement) and the flat pieces below it and the piece to the left foreground that appears discoloured greenish were **asbestos**, not fibre cement. It was all eventually covered with spoil.

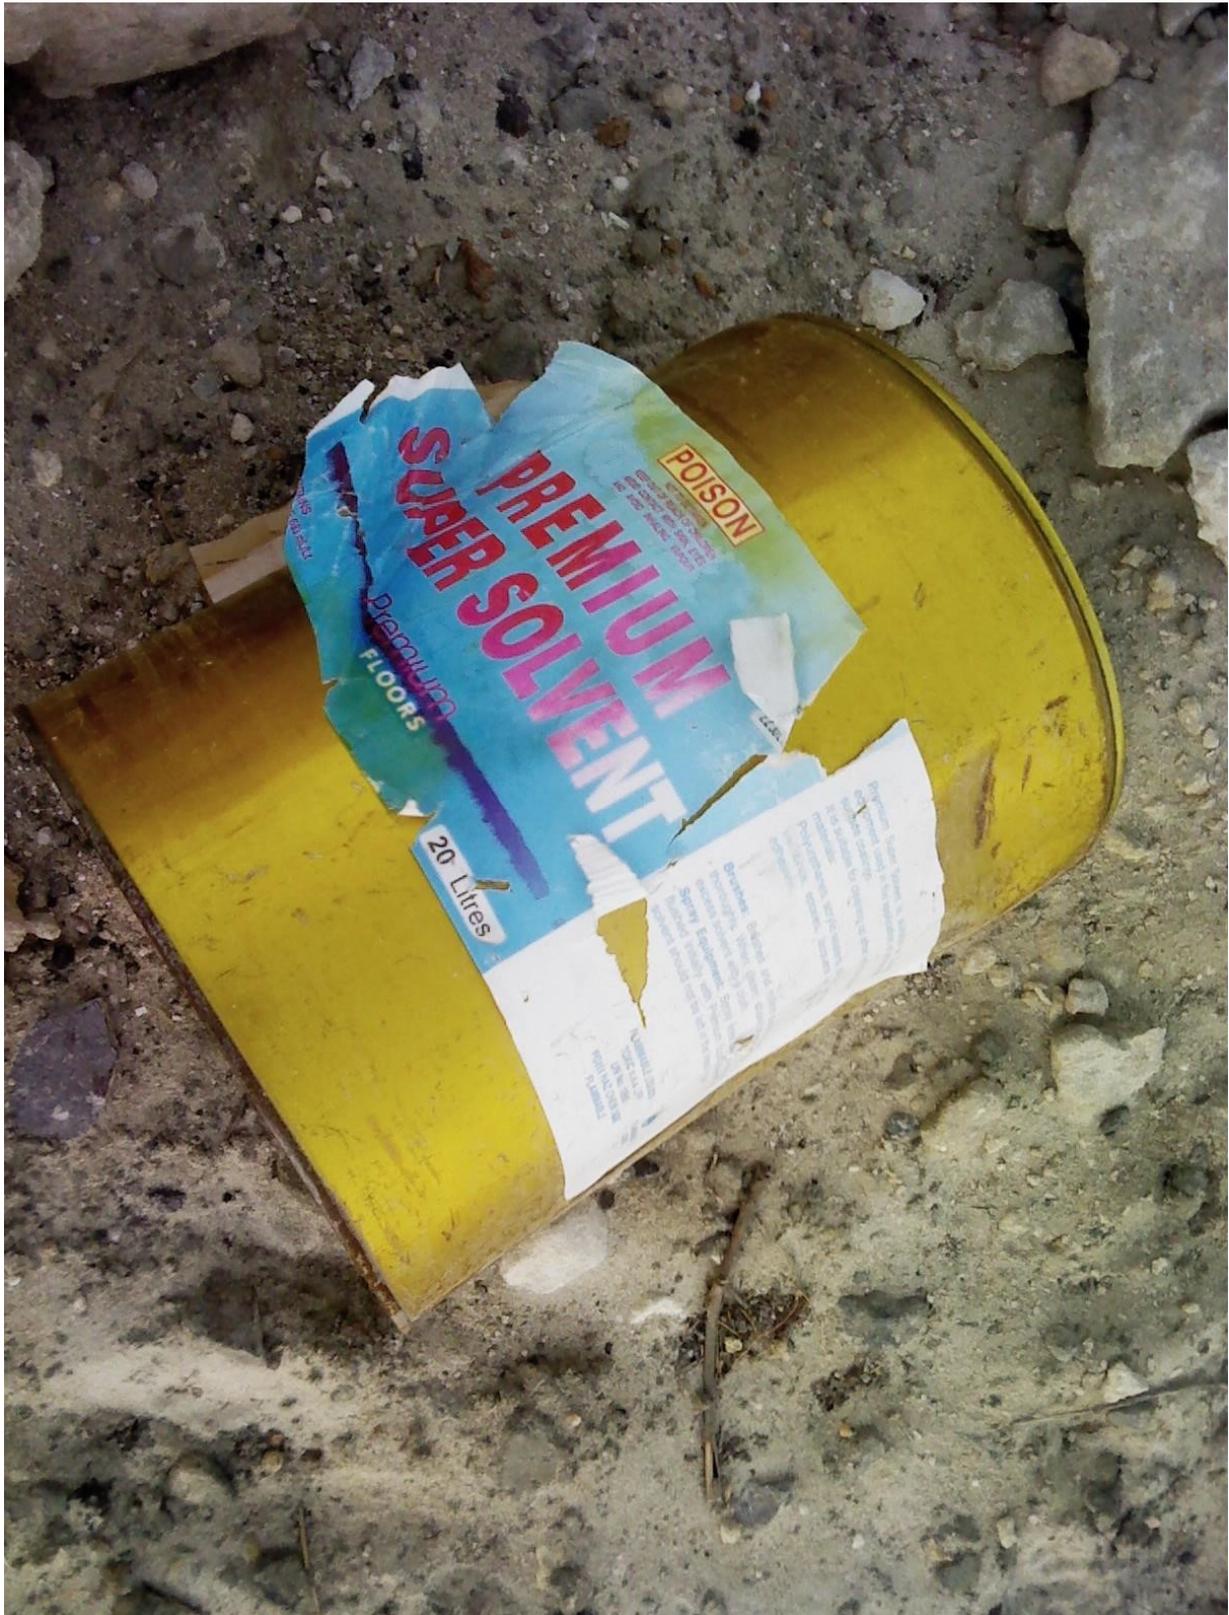
Photo 15. Current inert fill site- 2014 Note greenish discolouration of soil from spilt solvent.

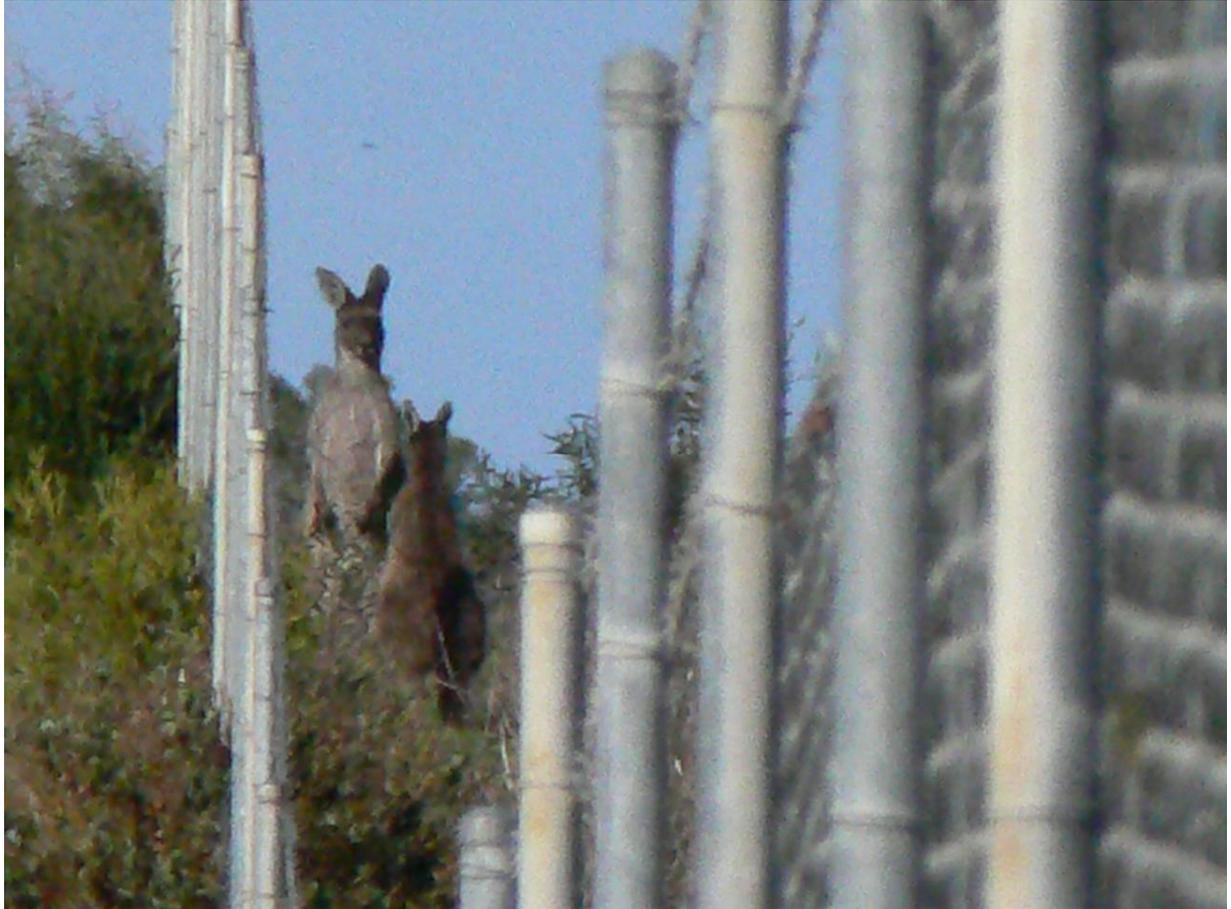
Photo 13. Current waste site. 2014. Kangaroos trapped inside fence.
